2021 TAILINGS SUMMARY REPORT

COMMITTED TO RESPONSIBLE TAILINGS MANAGEMENT

AGNICO EAGLE

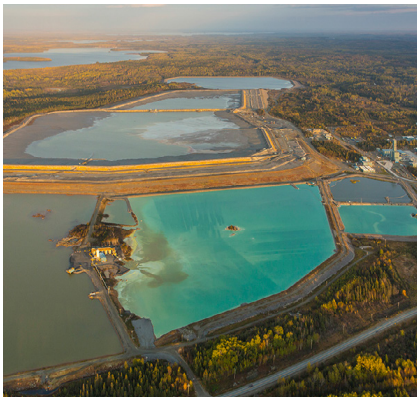
Example of slurry tailings facility
LaRonde complex

Some of Agnico Eagle's sites deposit tailings as a slurry (LaRonde mining complex), which can release significant excess water after placement; or as thickened tailings (Canadian Malartic mine), which release only minor amounts of excess water after the placement; or, as filtered tailings (Pinos Altos and Meliadine mines), which do not release excess water after placement. See Appendix B for the definitions of the different types of tailings.

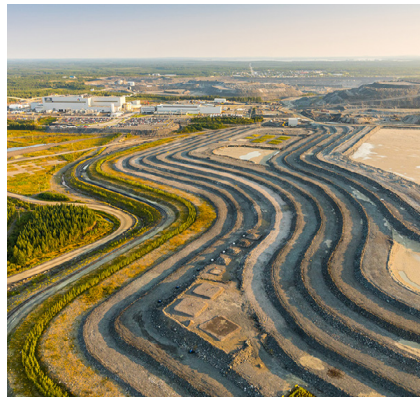
Example of thickened tailings facility
Canadian Malartic mine

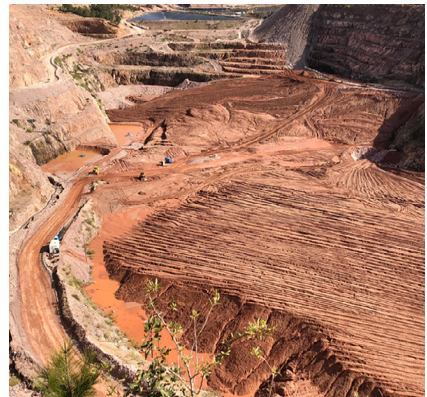
Example of filtered tailings facility
Pinos Altos mine

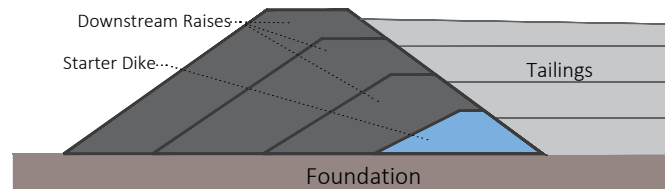
Figure 2: The **downstream method** involves constructing each raise on top of and downstream of the previous stage. The dike is founded entirely on natural soil. It is usually the method that requires the highest quantities of borrow material volume and space downstream.

The four methods shown here (upstream, downstream, centreline and in-pit) are basic concepts; in practice, there is a wide variety of geometries and techniques used in the design and construction of TSFs.

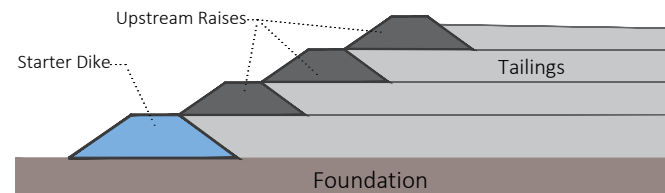
Figure 3: The **upstream method** involves constructing each raise in the upstream direction such that they are partially supported on the tailings deposited after the previous raise. When properly designed, constructed, and operated, this methodology can be very safe. However, a robust understanding of the tailings strength parameters is essential during the design phase of such facility.

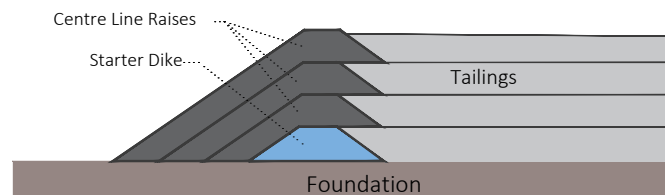
Figure 4: The **centreline method** is a combination between the upstream and downstream methods. The raises are essentially constructed on top of one another without significant reliance on the tailings and limited encroachment on the downstream terrain.

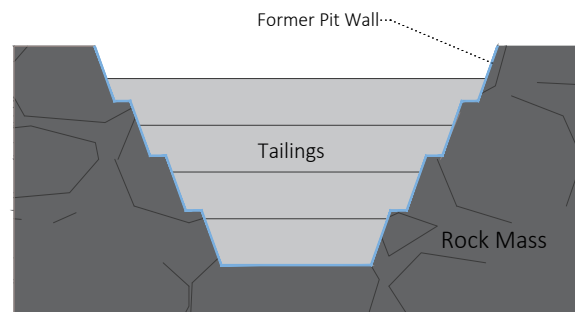
Figure 5: The **in-pit method** consists of the use of an open pit to store tailings after mining activities have ceased. Once such facility is available, it becomes a tangible opportunity to use this capacity to store any type of tailings. It also provides advantages with respect to stability since it does not involve any retaining infrastructure such as a dam or a dike. At Agnico Eagle, two operations are currently using this methodology.

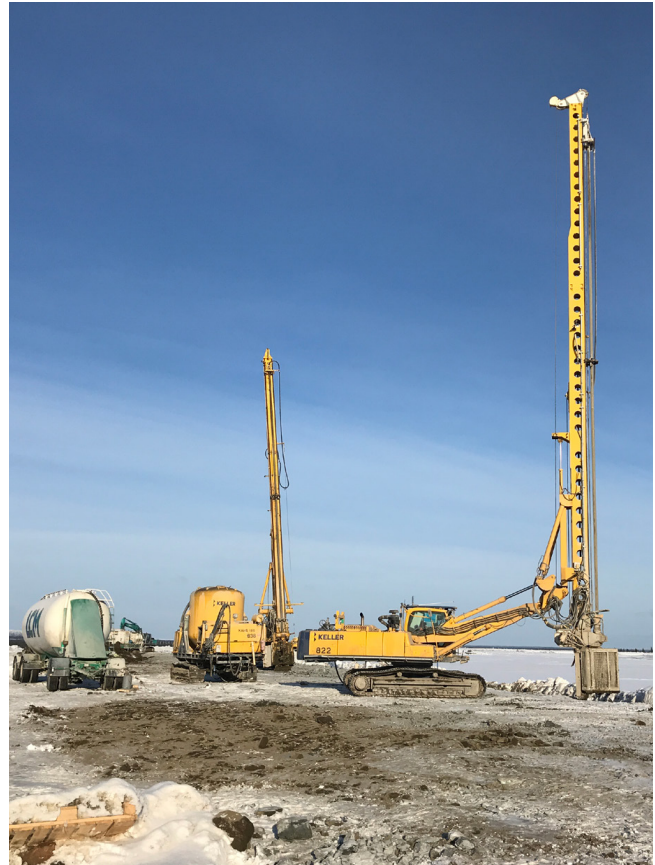
Deep Soil Mixing Technology
Kittilä mine

- As a partner of the Research Institute on Mines and Environment (RIME) UQAT–Polytechnique, Agnico Eagle supports and participates in research that addresses the management of TSFs. Through this research, a series of large-scale experimental cells have been constructed to test the long-term performance of final tailings pond covers for the LaRonde complex and the Canadian Malartic mine.
- Some of the innovations resulting from this research have already been implemented at our sites, such as the use of waste rock inclusions at the Canadian Malartic mine.
- Our Kittilä mine in Finland has utilized foundation improvement technology (Deep Soil Mixing) to improve the tailings that will be used as a foundation for an upstream raise.

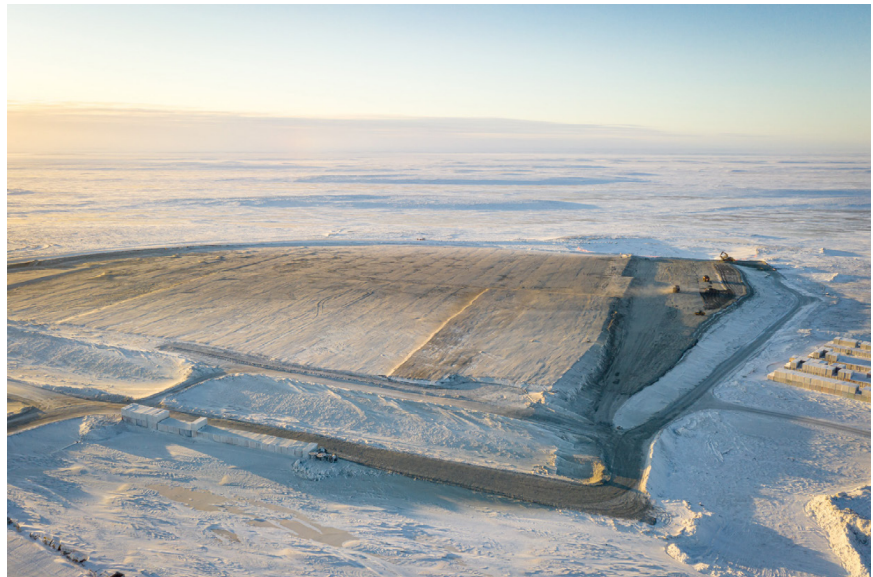
Filtered tailings deposition at our
Meliadine mine in Nunavut.

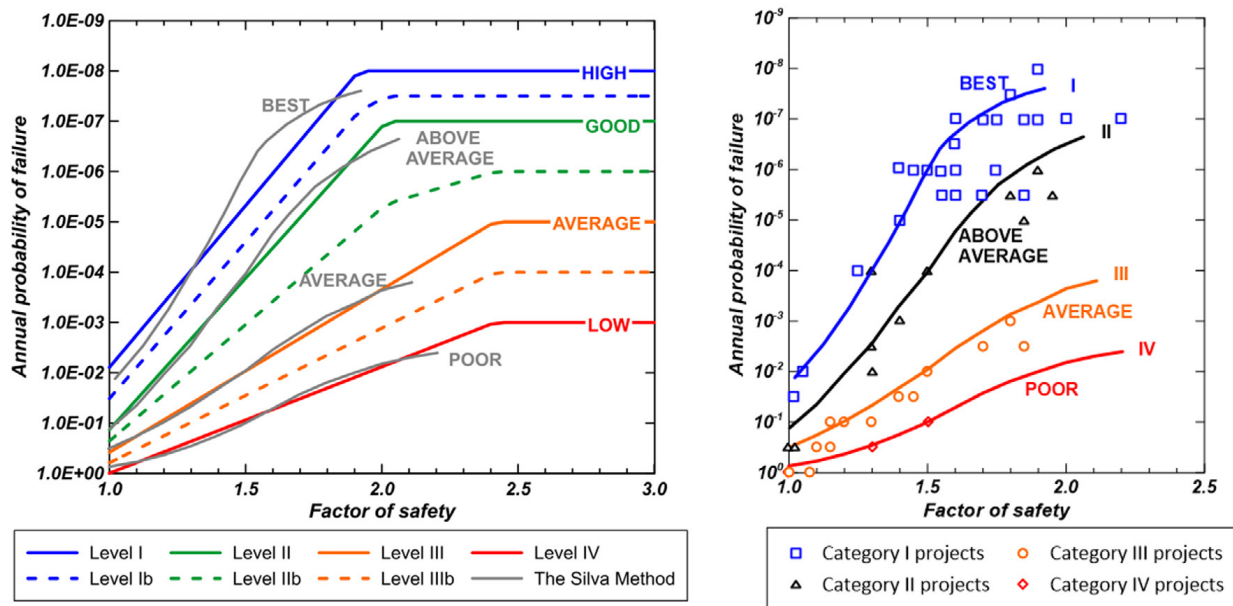
In general, the evaluation is broken into several steps, and involves the use of empirical relationships developed between annual probability of failure (APF), factor of safety (FS) and level of practice (LOP), as shown in Figure A, alongside the well-recognized published work of Silva et al. (2008), which formed the basis of this updated method.

Figure A: Factor of Safety vs. Annual Probability of Failure a) Chovan, et al. (2020) and b) adapted from Silva, Lambe & Marr (2008)

4. With the LOP and the static FS, the Annual Probability of Failure (APF) was derived using the modified FS-LOP-APF relationships in Figure Aa.
5. Consequences of failure are assessed for the infrastructure assuming it will fail completely and independently of its actual probability for failure. Review of the dam-break and run-out analyses facilitates determination of the appropriate potential consequences, in four categories: health and safety, financial, environmental, and community. The potential consequences considered per consequence rating are described in Tables A through C.
